Manhole Inspection Summary

Manhole # S47C__020MH

Insp Date: **7/14/08 11:10 AM**

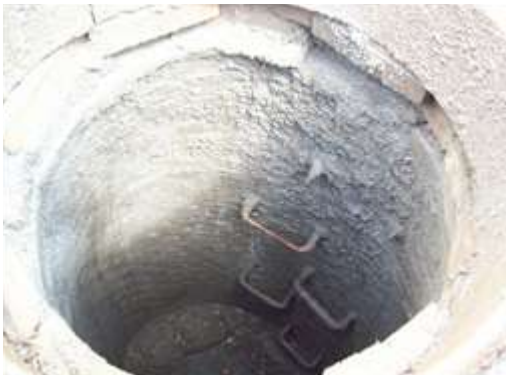
Defect 1

Condition: ☐ Sound ☐ Cracked ☐ Root Intrusion ☒ **Loose Brick** ☐ Deteriorated

loose brick

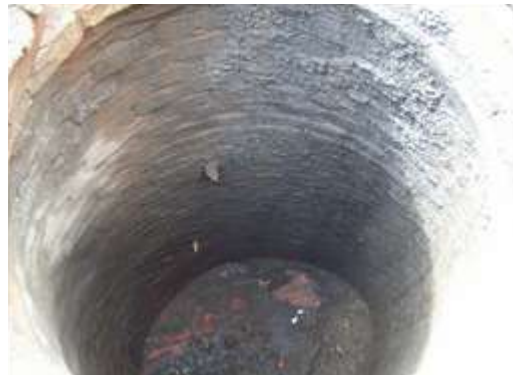
Defect 2

Infiltration: ☐ None ☒ **Joint** ☐ Cracks ☒ **Mortar** ☐ Roots ☐ Wall

infiltration

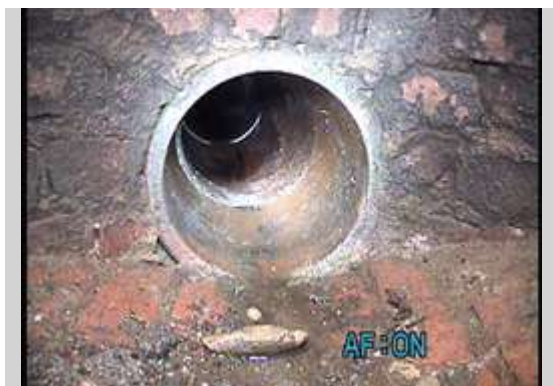
12 O'Clock Outflow

8 in. Circular Gravity Sewer
Pipe Out @ 12 O'Clock

Infiltration: **None** Pipe Seal Cond: **Sound**
